Grantham Floods Commission of Inquiry

Report

October 2015

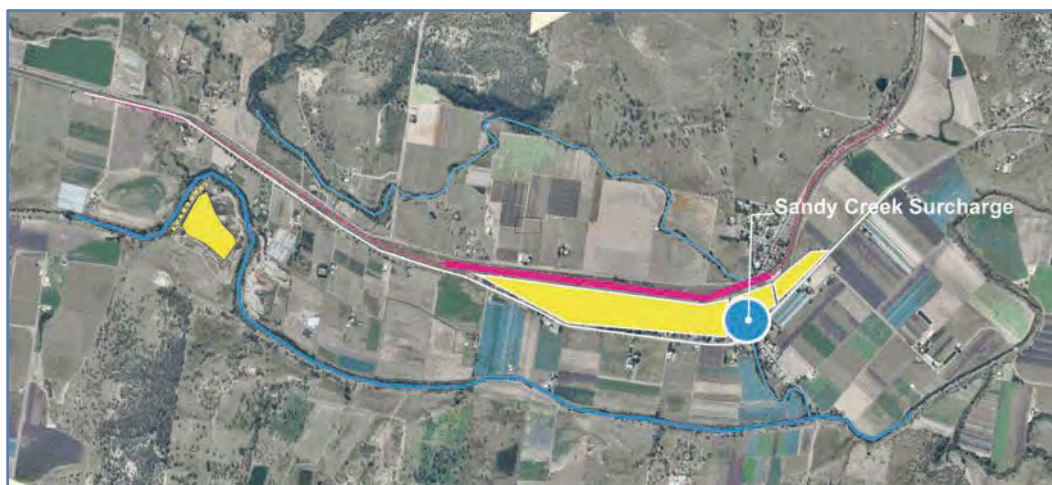
Figure 5.5: Diagram of first stage of flooding Grantham

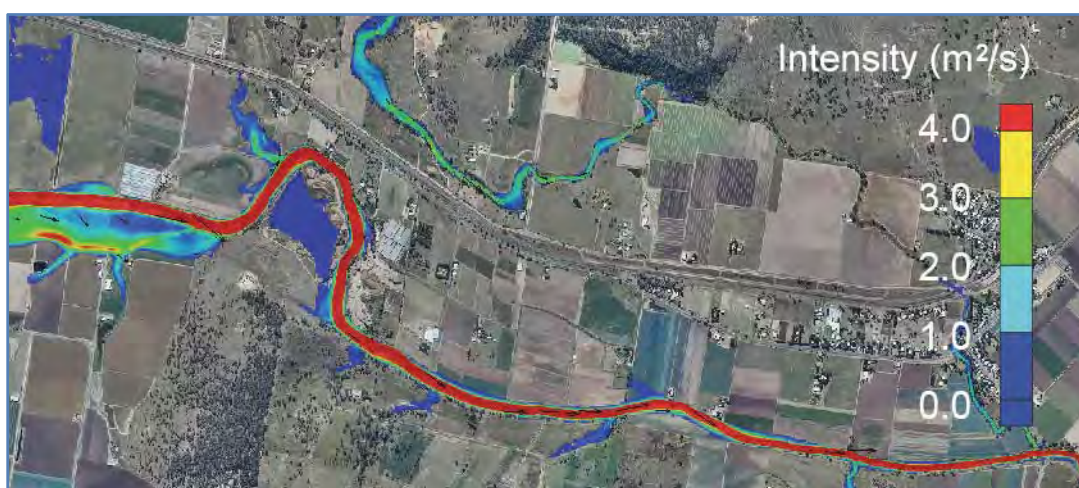
Figure 5.9: Image of modelled water levels at 3:15 pm on 10 January
Source: Exhibit 144, John Macintosh, Most likely scenario animation

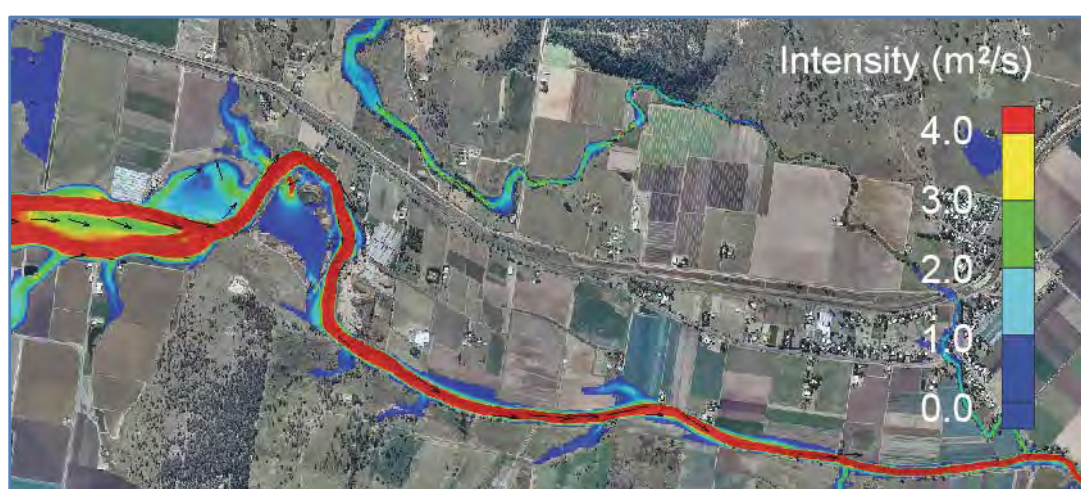
Figure 5.13: Image of modelled water levels at 3:25 pm on 10 January 2011

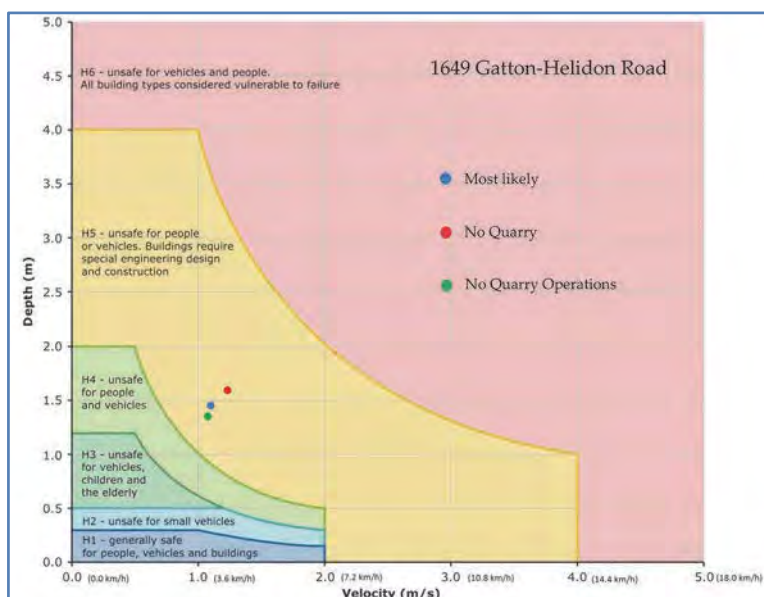
Figure 5.28: Depth, velocity, intensity and hazard at 1649 Gatton-Helidon Road

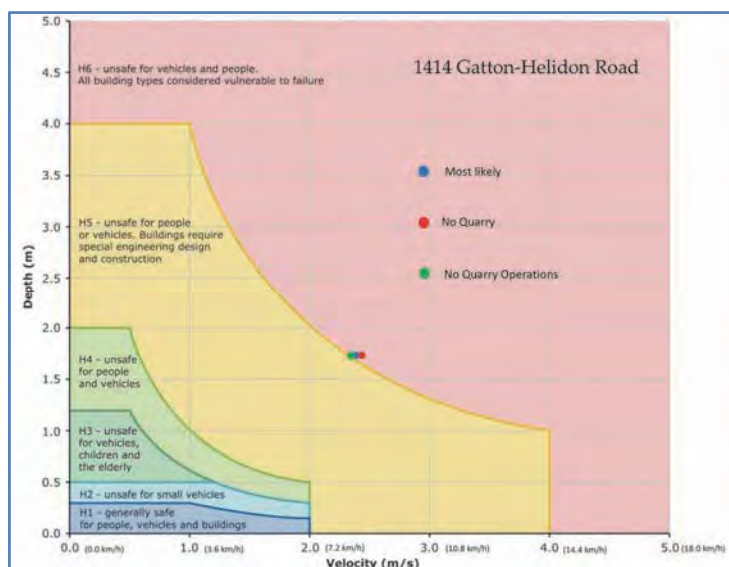
Figure 5.30: Depth, velocity, intensity and hazard at 1414 Gatton-Helidon Road
Source: Exhibit 142, Grantley Smith, *Expert Opinion: Stability of People, Vehicles and Buildings in Flood Water*, 13 August 2015 [p6: Figure 3] (amended)

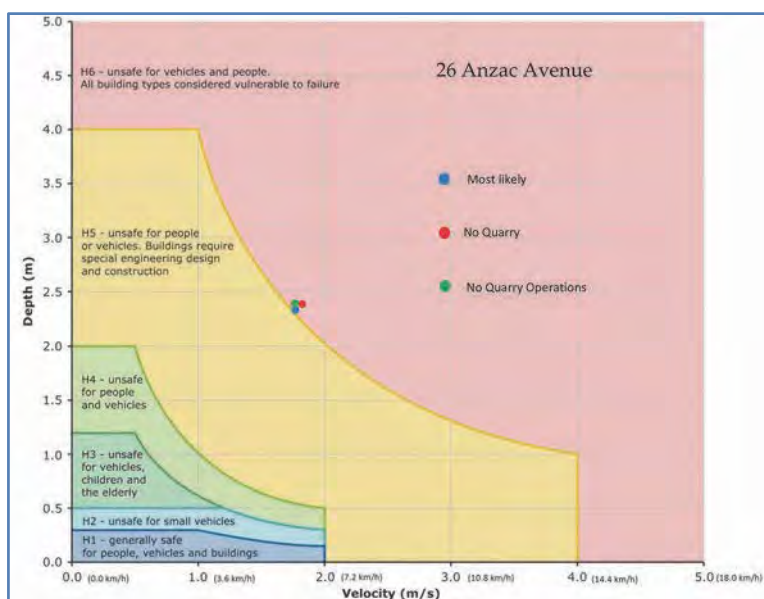
Figure 5.31: Depth, velocity, intensity and hazard at 26 Anzac Avenue
Source: Exhibit 142, Grantley Smith, *Expert Opinion: Stability of People, Vehicles and Buildings in Flood Water*, 13 August 2015 [p6: Figure 3] (amended)

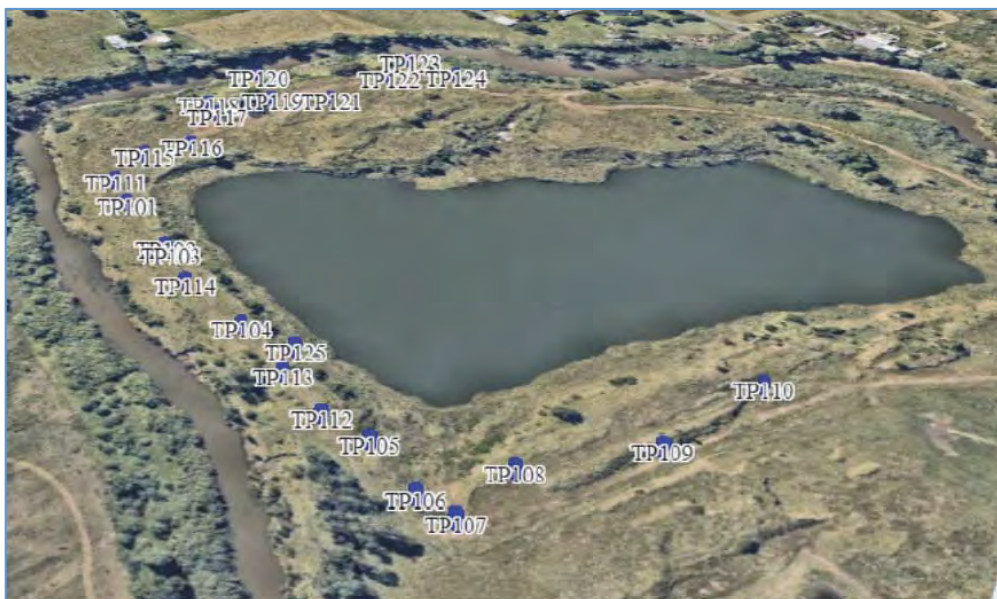
Figure A1: Test pit locations shown on 2015 Nearmap image.

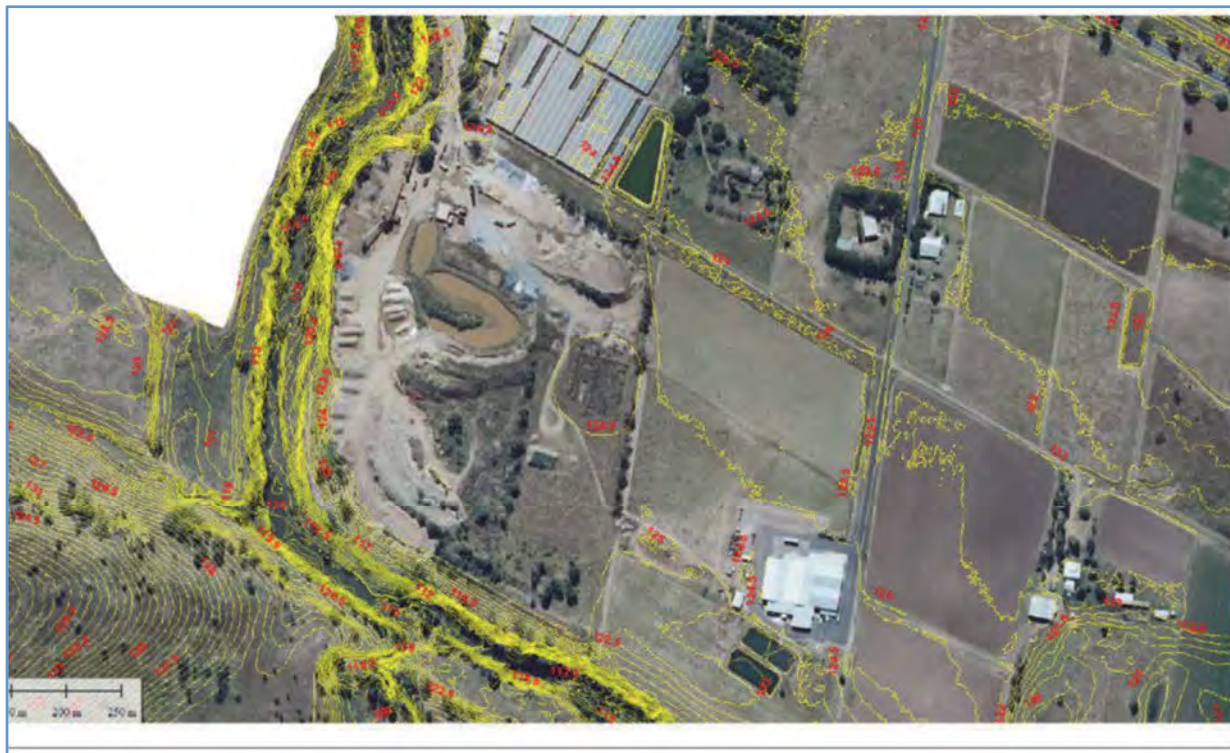
Figure A17: Reconstructed topographic plan of Batching Plant Site prior to development.

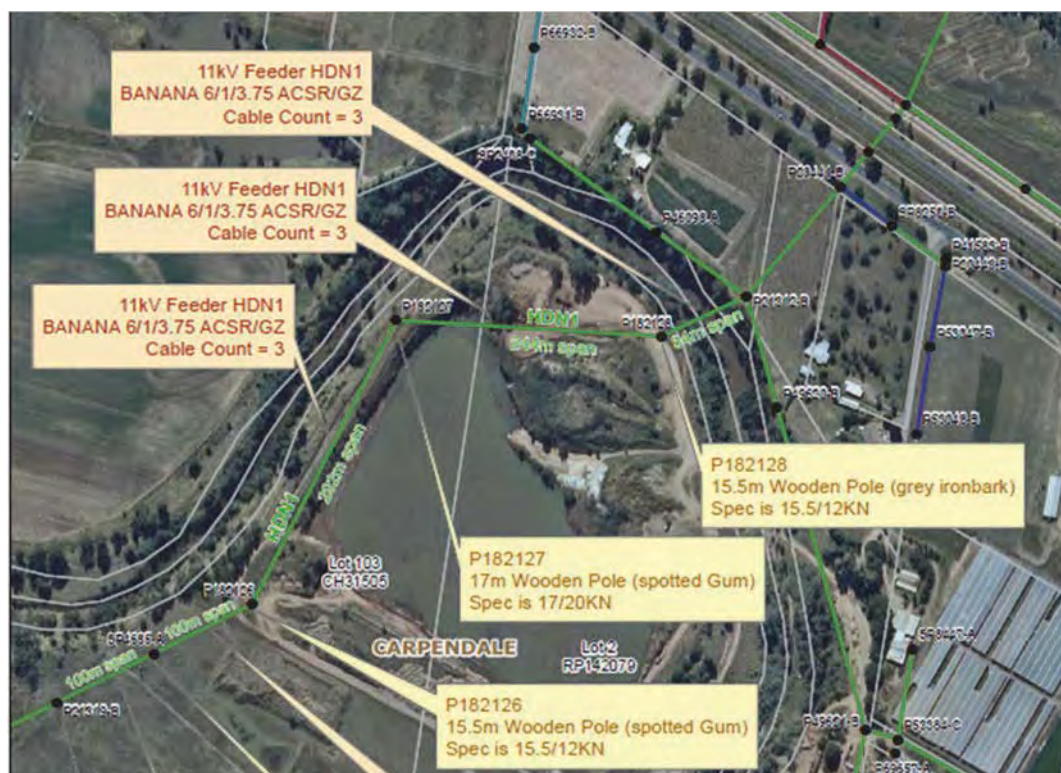
Figure B1: Location and connections for the broken pole.

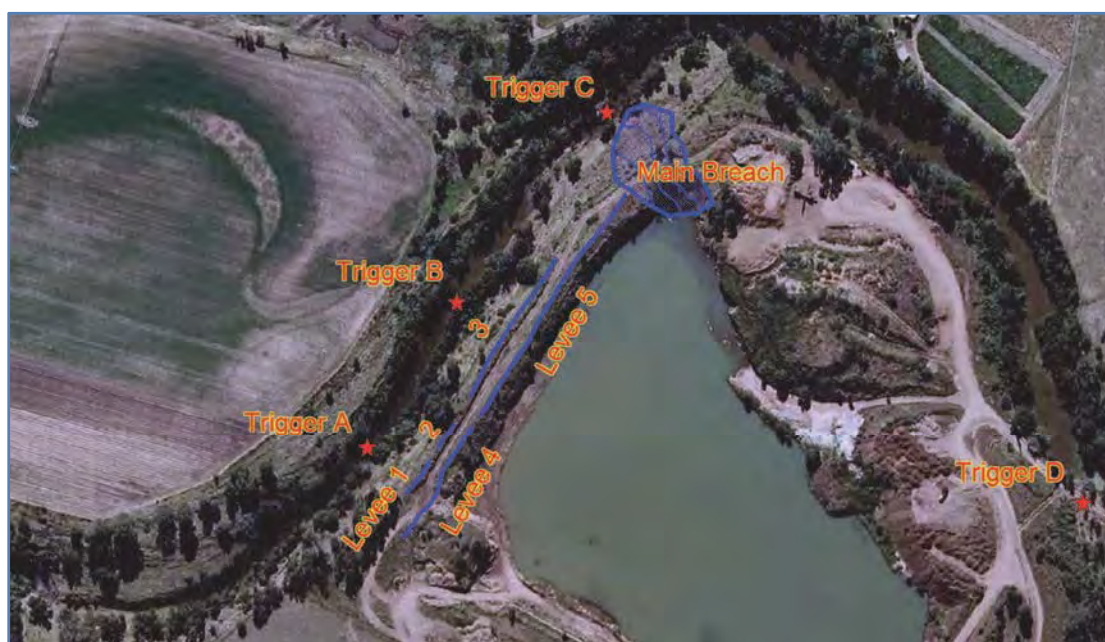
Figure C10 – Quarry failure trigger level locations

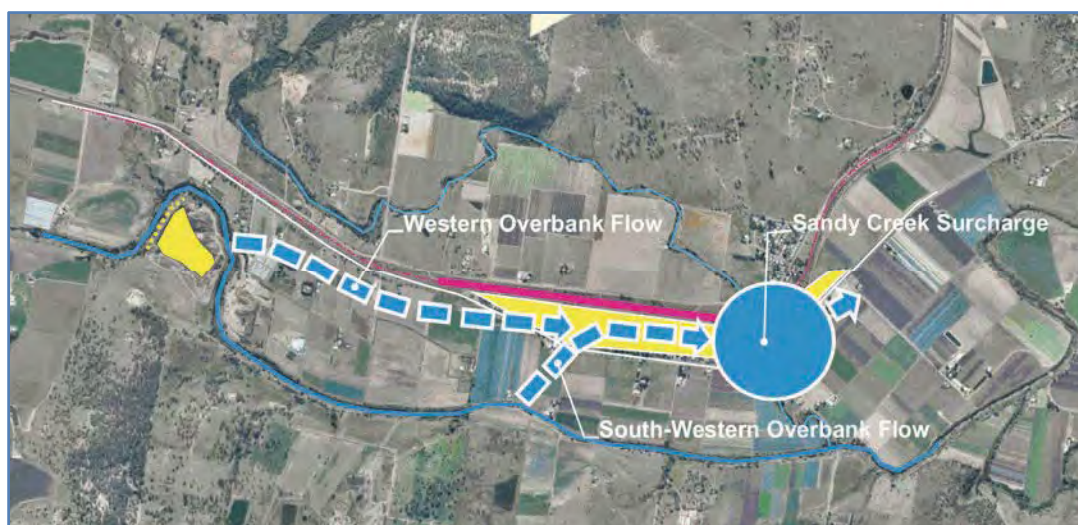
Figure C13: Simplified flooding locality, western overbank inundation.

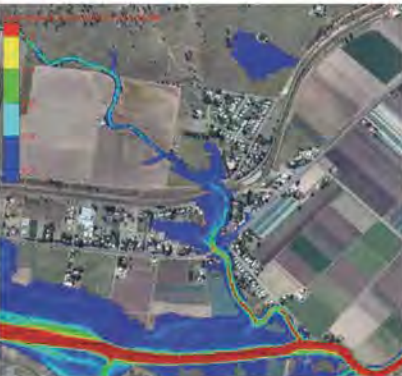
<p>(c) 3:55pm</p> <ul style="list-style-type: none"> Lockyer Creek has broken its banks with inundating flows rapidly approaching Grantham from the South-Western Overbank flow path. The Gatton-Helidon bridge over Sandy Creek has now been overtopped and within 1 minute the depth will exceed 0.3m (my estimated time of closure for evacuation purposes). This will result in closure of the last evacuation route for Western Grantham. Note that erosion of the Main Breach has completed. Note that erosion of the bunds in the Western Levee (other than in the area of the Main Breach) have commenced.

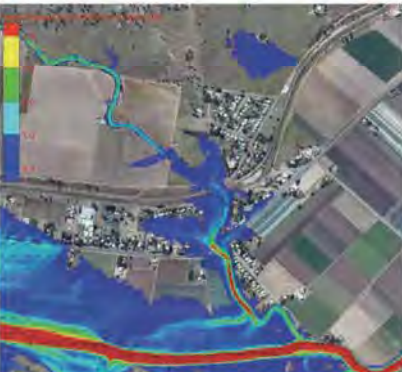
<p>(d) 4:00pm</p> <ul style="list-style-type: none"> Floodwater from Lockyer Creek over the South-Western Overbank flow path has overtopped the Gatton-Helidon Road in Western Grantham, but these floodwaters have not yet reached the road within Central Grantham. Sandy Creek surcharge is continuing to inundate Central Grantham, but not as quickly as it is occurring in Western Grantham.
